**A PUBLIC HEARING AND REGULAR MEETING
OF THE TOWN OF LADYSMITH COUNCIL
AGENDA
5:00 P.M.**

Tuesday, June 15, 2021

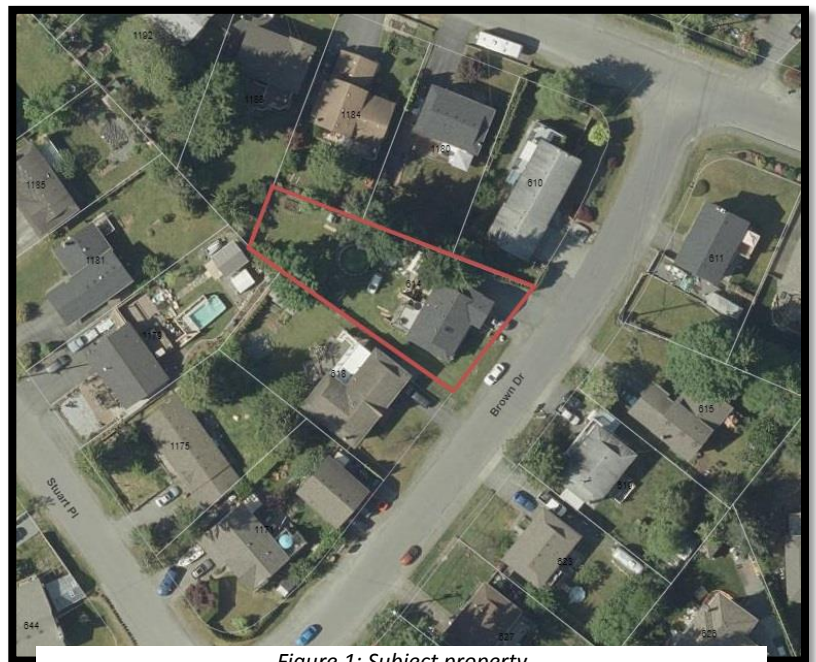
Figure 1: Subject property

The subject property, 614 Brown Drive, is located within a predominately single-family residential neighbourhood and contains an existing dwelling with an attached balcony on the front. The existing balcony is narrow and the applicant is proposing to extend it in order to allow wheelchair access. Stairs with a chairlift from the balcony to the ground are also proposed. The applicant has provided a letter of rationale for the proposal (Attachment B).

The siting of the dwelling and proposed balcony close to the front parcel line is not out of character with neighbouring parcels on Brown Drive (see Figure 1). As such, the proposed setback variance for the balcony is not expected to have a negative impact on the surrounding neighbourhood and it is therefore recommended that DVP 3090-21-05 be approved.

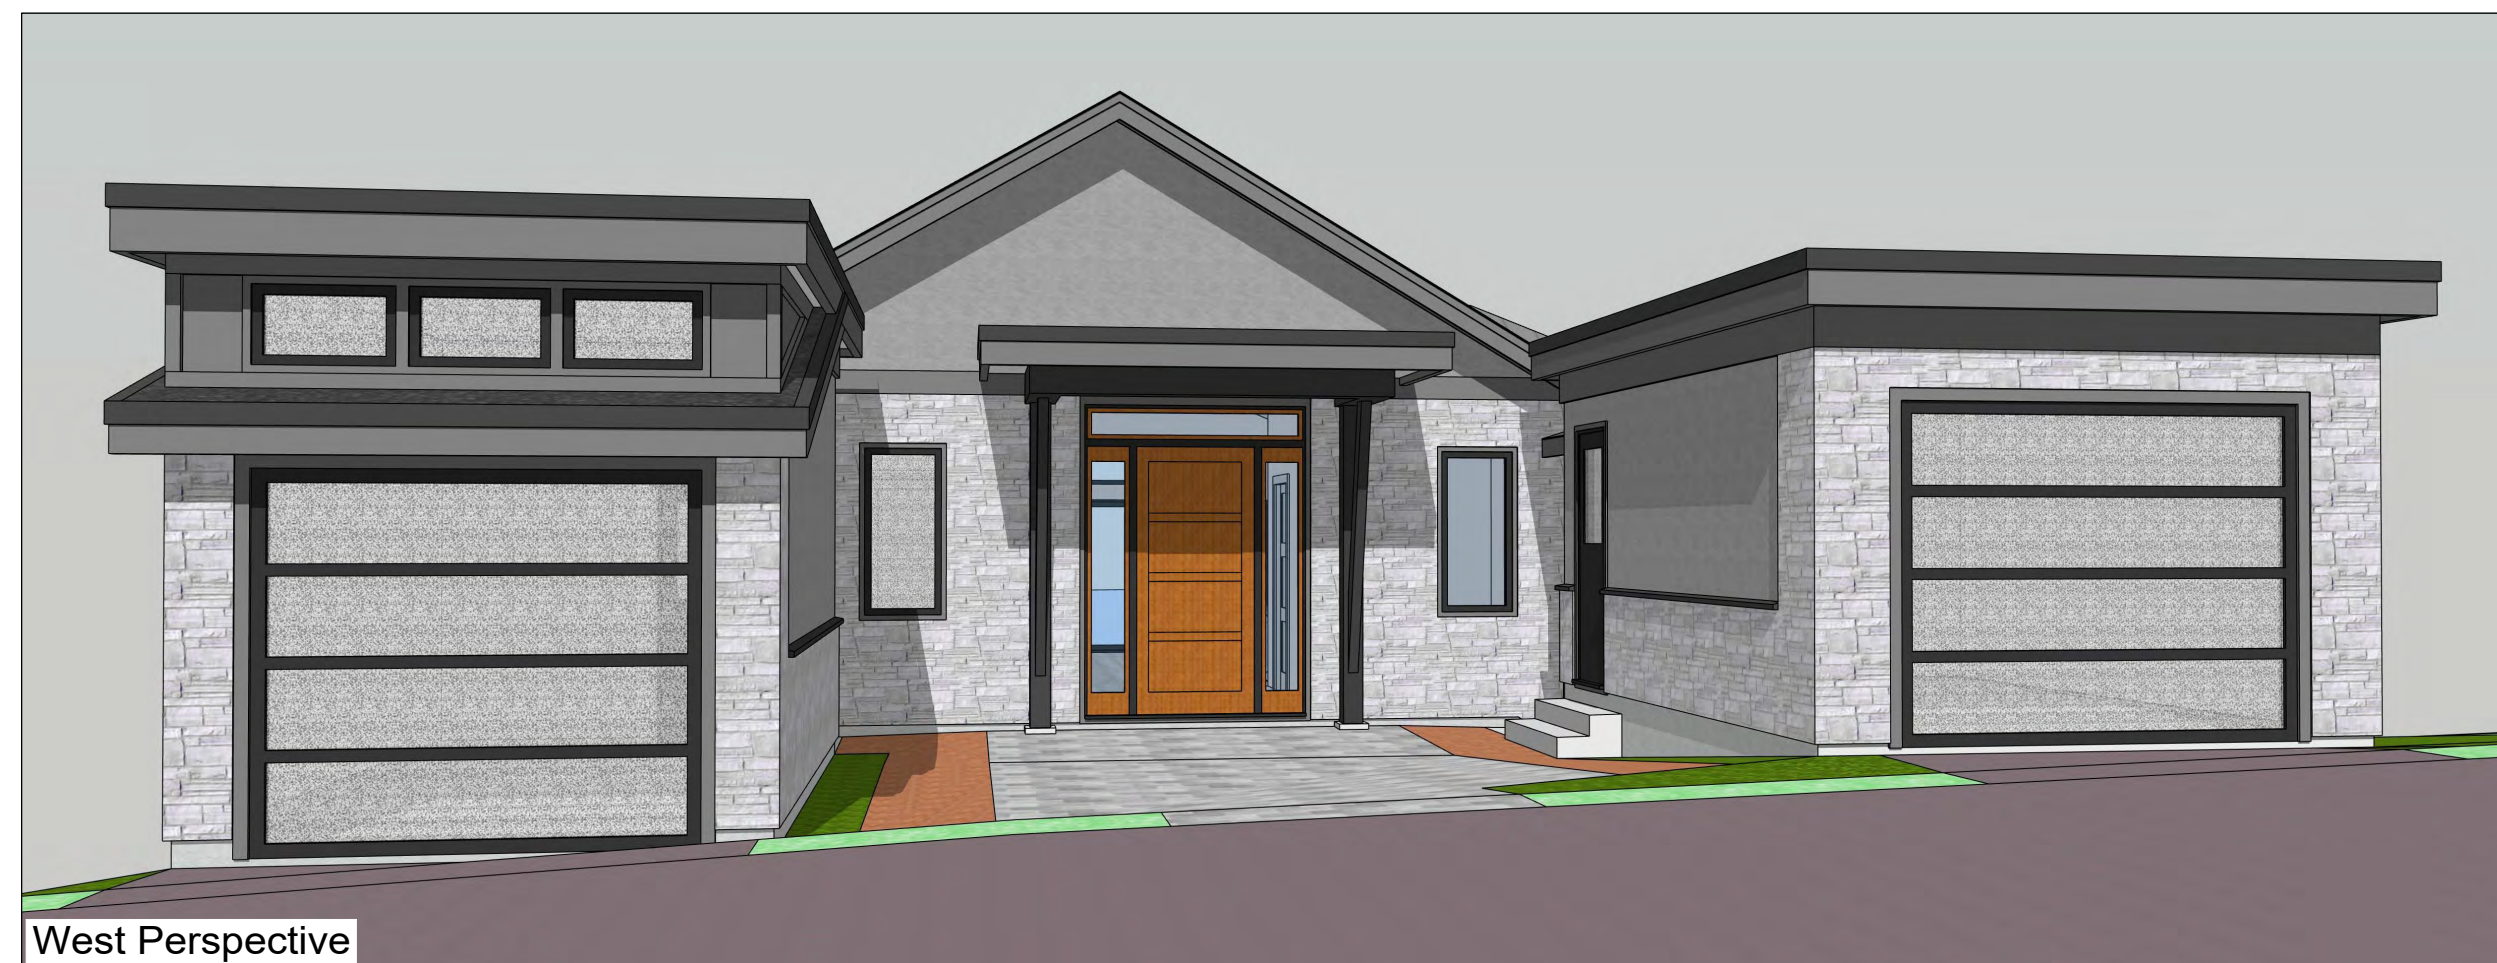
West Perspective

Note: This Schedule applies to the accessory buildings (north and south garages) only. An alternative colour scheme is permitted.

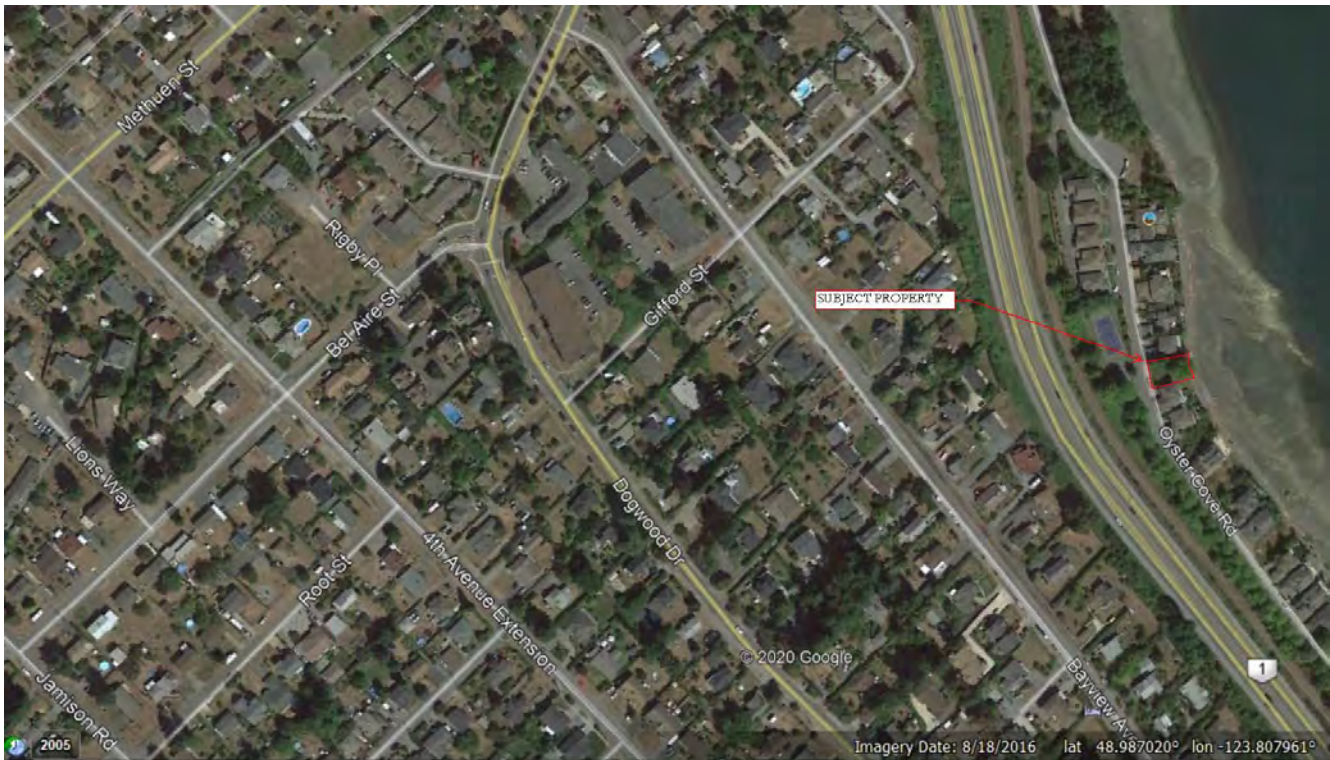
Figure 1.1 – Site Location (Satellite Imaging from Google Earth®)

- a. The Property is located on the east coast of Vancouver Island and borders the Strait of Georgia. See Figure 1.1 below.

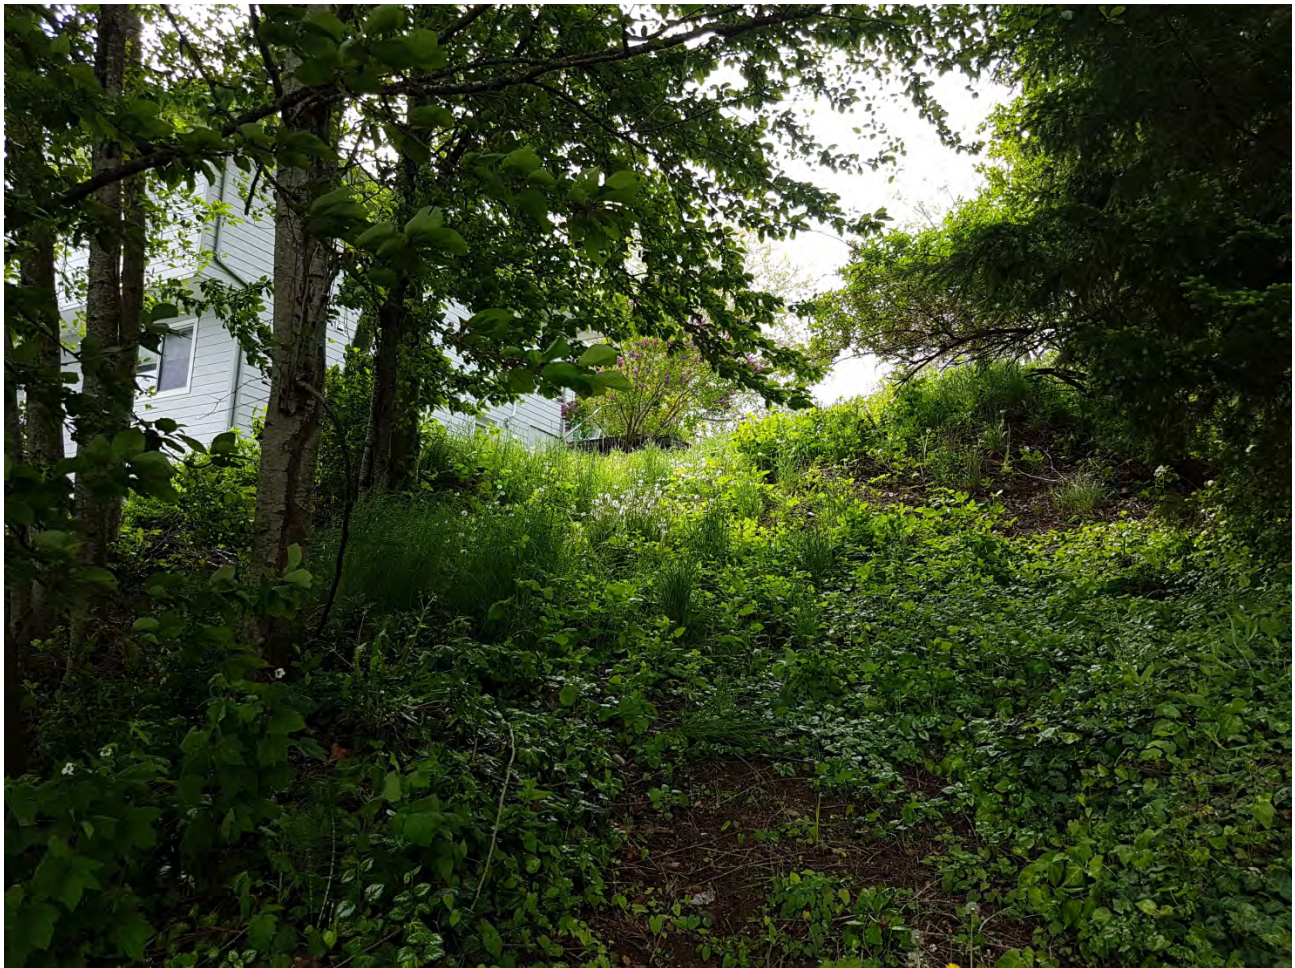
Figure 2.2 – Site Conditions

- c. The lot's surface is covered in berry vines, some smaller boulders and woody debris and some mature trees. Developed areas nearby are landscaped with small trees, gardens and paved driveways and parking areas. The Property's surface is shown in Figure 2.2.

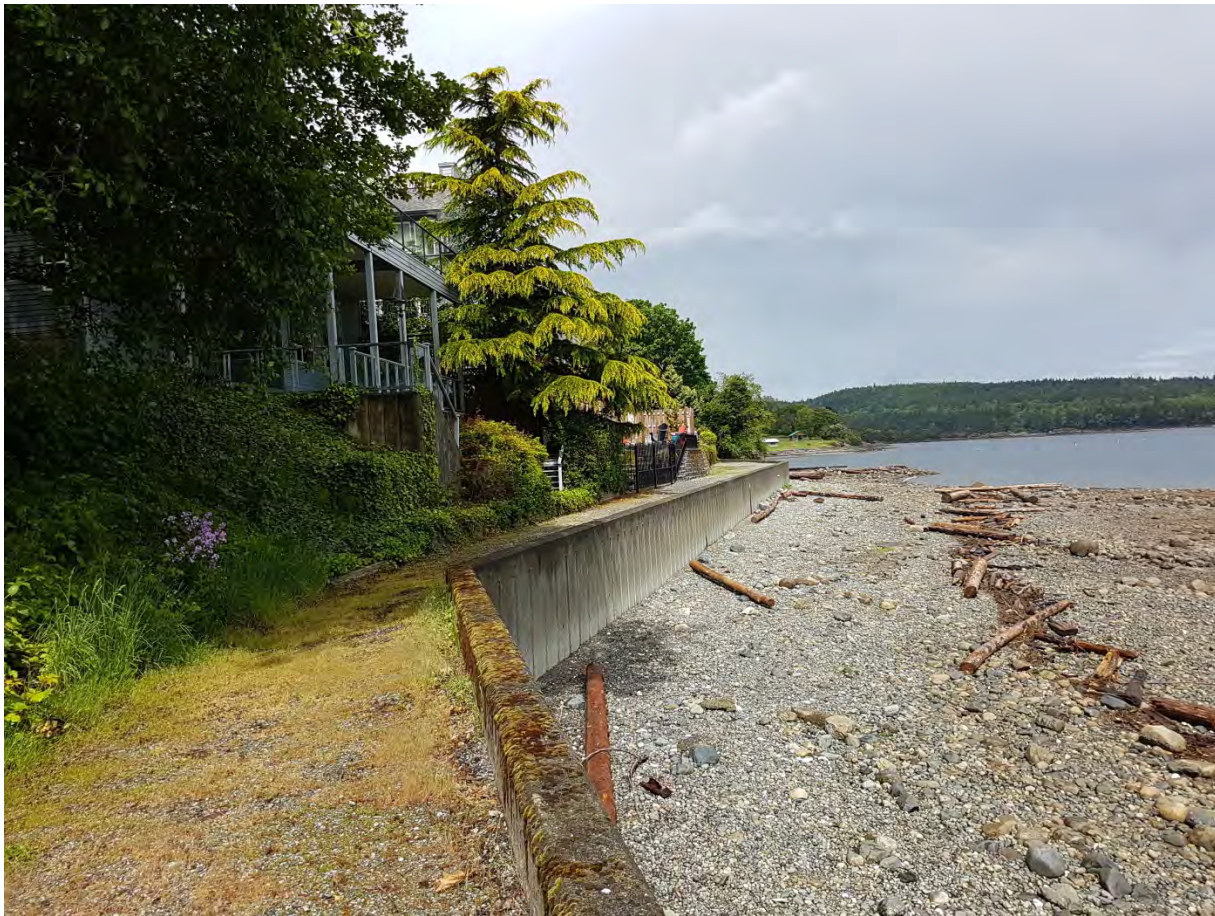
Figure 2.5 – Foreshore Condition

- a. The foreshore can be characterized as a low-medium bank intertidal zone facing the Ladysmith Harbour (Strait of Georgia) to the northeast. A common seawall and sidewalk fronts the entire development. The total height of the foreshore slope, including the 2.0m high seawall, was approximately 3-4 m at the time of our assessment. Evidence of scouring or undermining of the seawall was not observed during the site visit.
- b. Foreshore soil conditions consist of loose to compact sand and gravel with some cobbles. Vegetation along the foreshore consisted of sea grasses, other small grasses and/or small plants. Large pieces of woody debris were observed. The foreshore conditions, at the time of our assessment, are shown below in Figure 2.5.

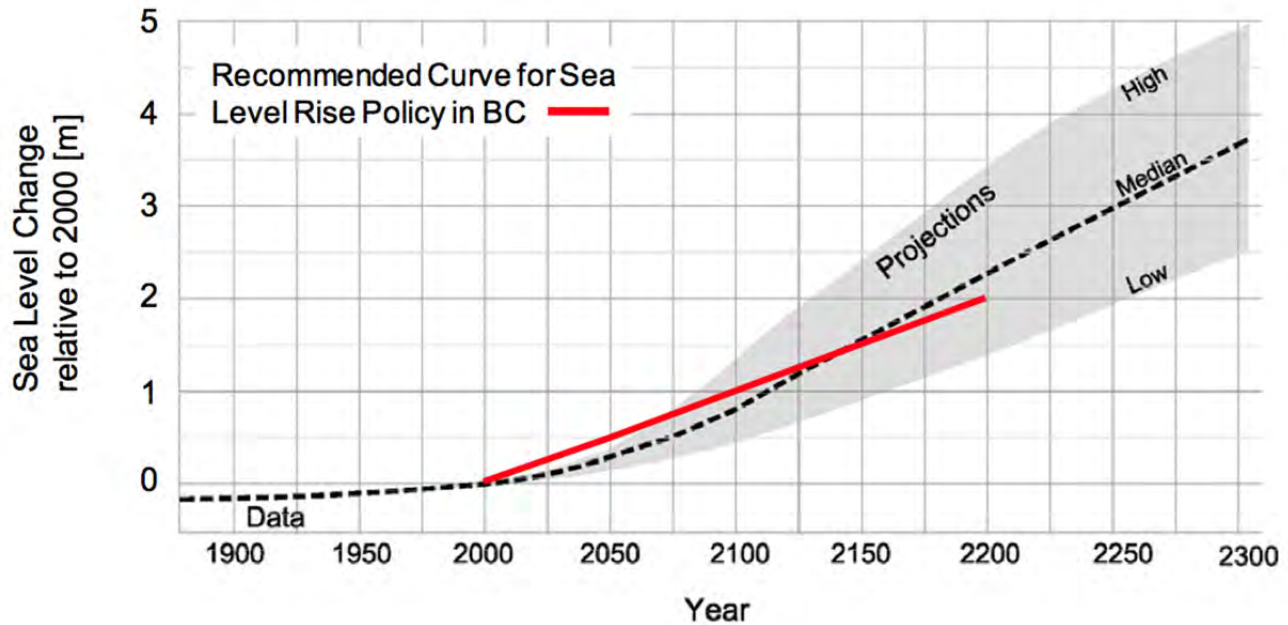
Figure 3.2 – Recommended Global SLR Curve for Planning and Design in BC

- a. Information prepared by the provincial government in 2011 regarding policy for coastal floodplain mapping assumes a 1.0m rise in sea level from the year 2000 to 2100³. See Figure 3.2 below.

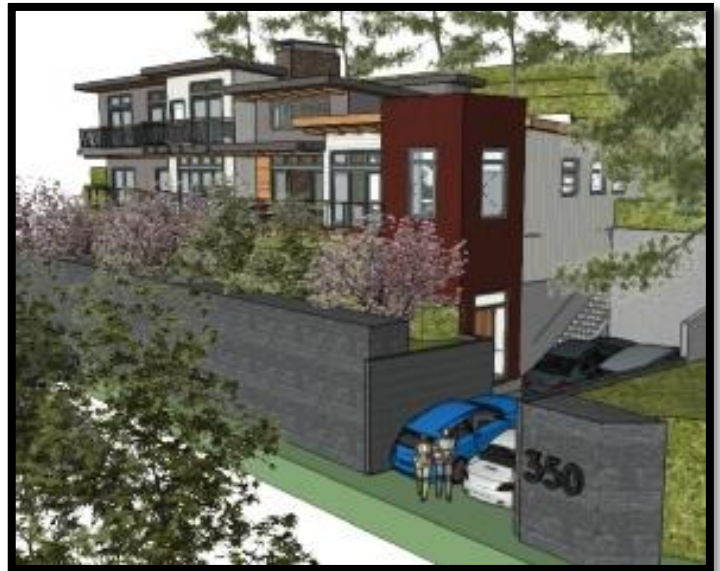
Figure 2: Side & front elevation of proposed dwelling and driveway as seen from Chemainus Road.

The application was referred to the Town’s Engineering Department for comment. Engineering has noted concerns with the sight lines available for the proposed driveway. A portion of the existing retaining wall will limit visibility for cars leaving the driveway, requiring them to pull into oncoming traffic before they can see oncoming traffic. Engineering has recommended that the applicant remove a small piece of the existing retaining wall from the northwest end (the portion where the address is shown on Figure 2) and slope back the grades to create more open sight lines of Chemainus Road and allow vehicles leaving the driveway to see oncoming traffic.

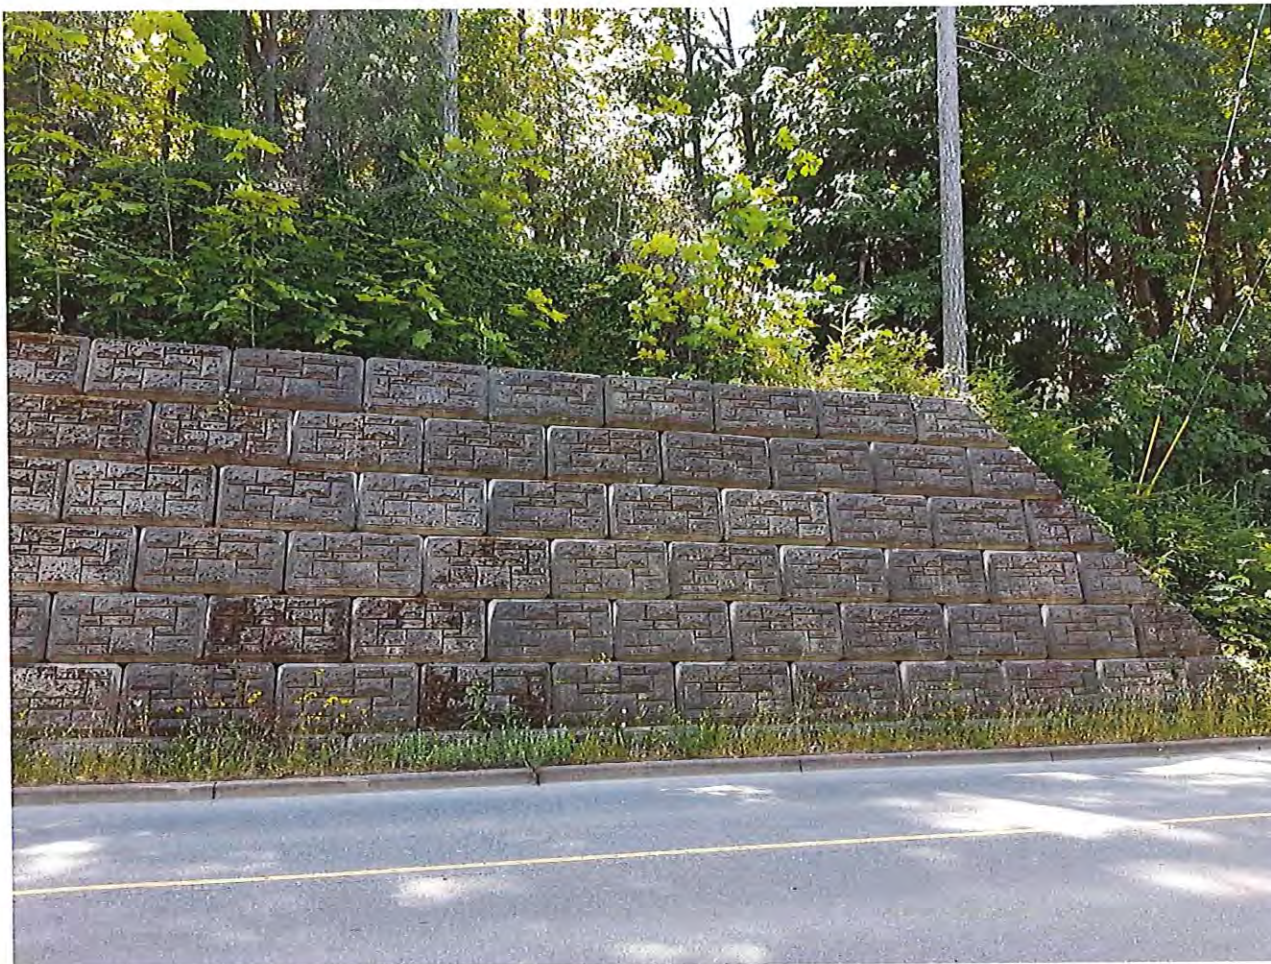
Photo 2.2: Retaining wall near northeast corner of the Property, looking southwest.

- c. An approximately 2.8m wide level bench is found immediately behind the wall. The level bench is partially comprised of a rock rubble fill drainage blanket for the retaining wall. The level bench abruptly transitions into an approximately 3.0m high near-vertical bluff, exposing native very dense glacial till soils. Above the bluff, the slope continues at slope angles between 25 to 30 degrees from horizontal. The southwestern property limits are defined by a railway embankment, estimated to be 1.5m in height with slope angles between 40 to 45 degrees from horizontal. Refer to Photo 2.2 below.

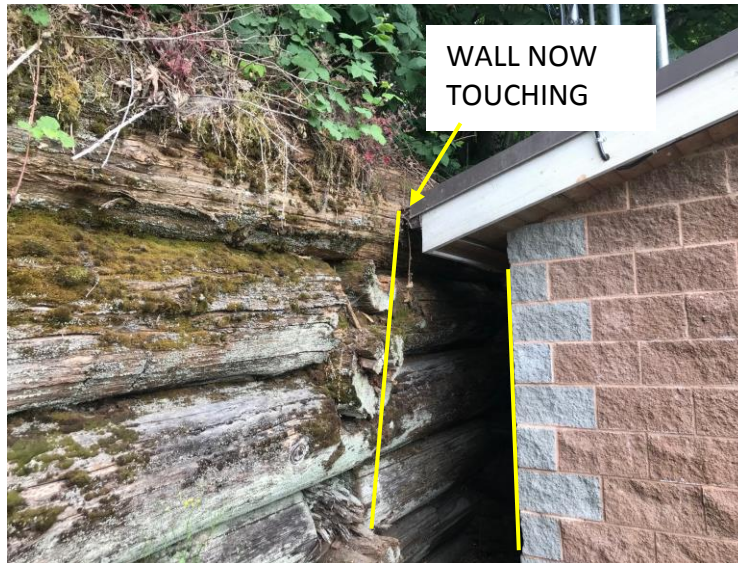
day of ,

Several remediation options have been presented by Tetra Tech, including reshaping the slope with various grades (Options A and B), a mechanically stabilized earth wall (Option C), and a soldier pile wall (Option D). Staff determined that the lowest cost option is to reshape the slope at a ratio of 1.5 horizontal distance to 1 vertical distance (1.5:1) (Option A); however, the toe of the slope will extend into the parking area where the existing utility building is currently sited.

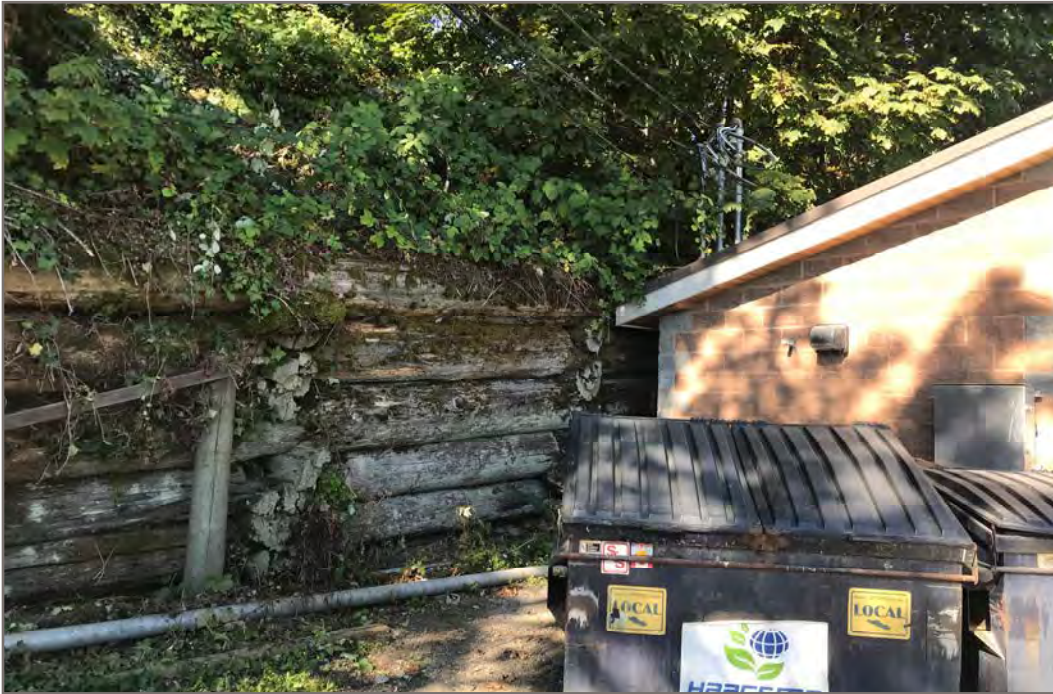
Photo 1: Failing Log Retaining Wall behind existing Power Building

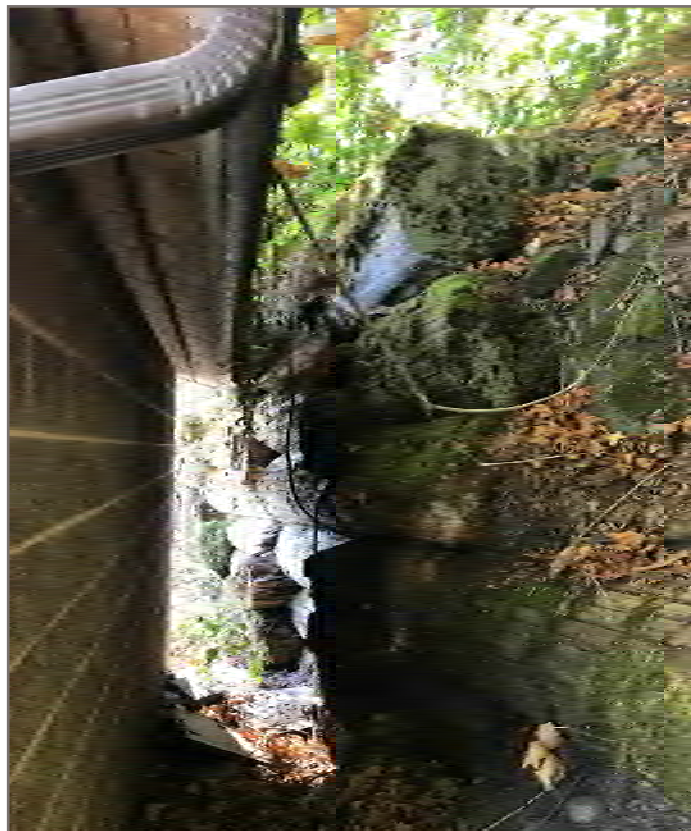
Photo 2: Failing Log Retaining Wall, Looking behind the existing Power Building

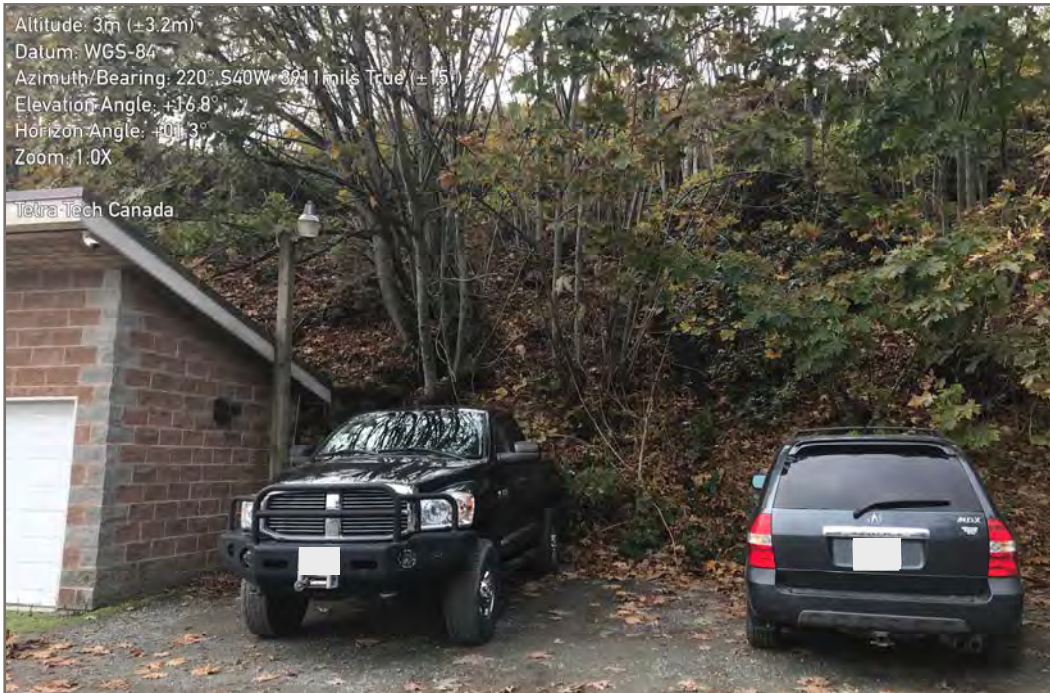
Photo 3: Slope Northwest of Failing Retaining Wall

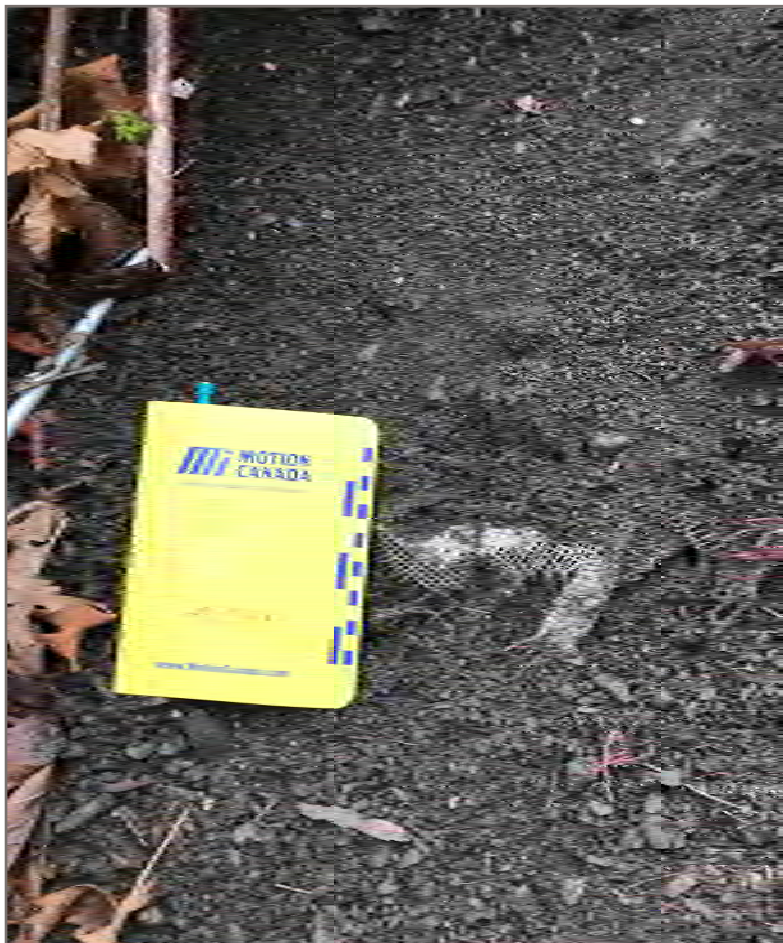
Photo 4: Erosion Protection Matting / Geotextile on Slope Northwest of Failing Retaining

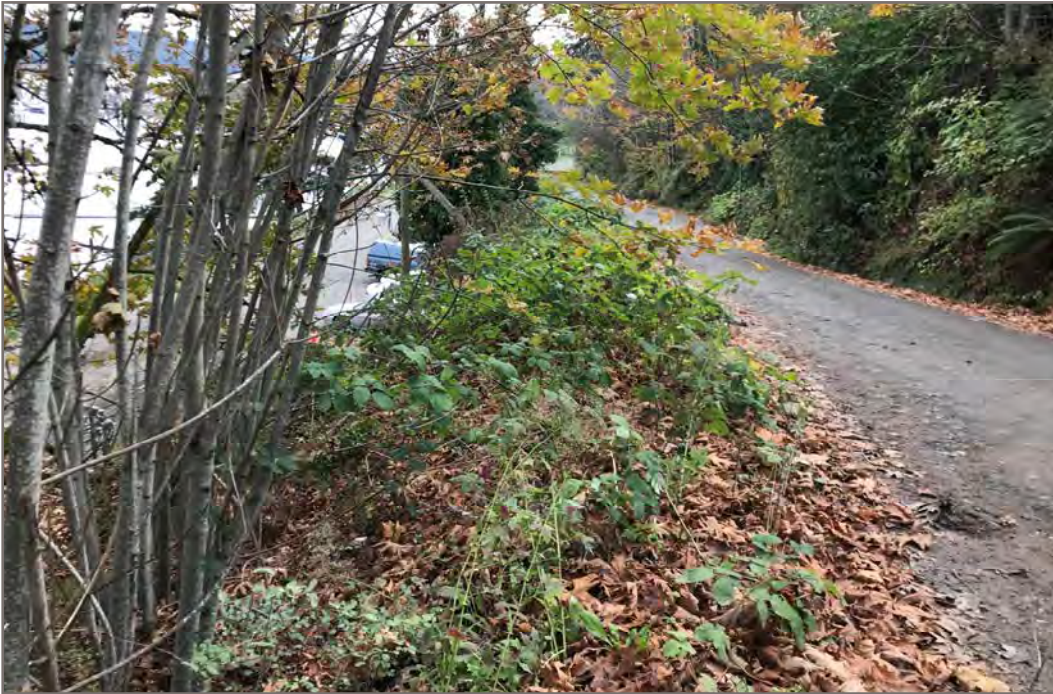
Photo 5: Oyster Bay Drive, above Failing Retaining Wall, Looking Southeast

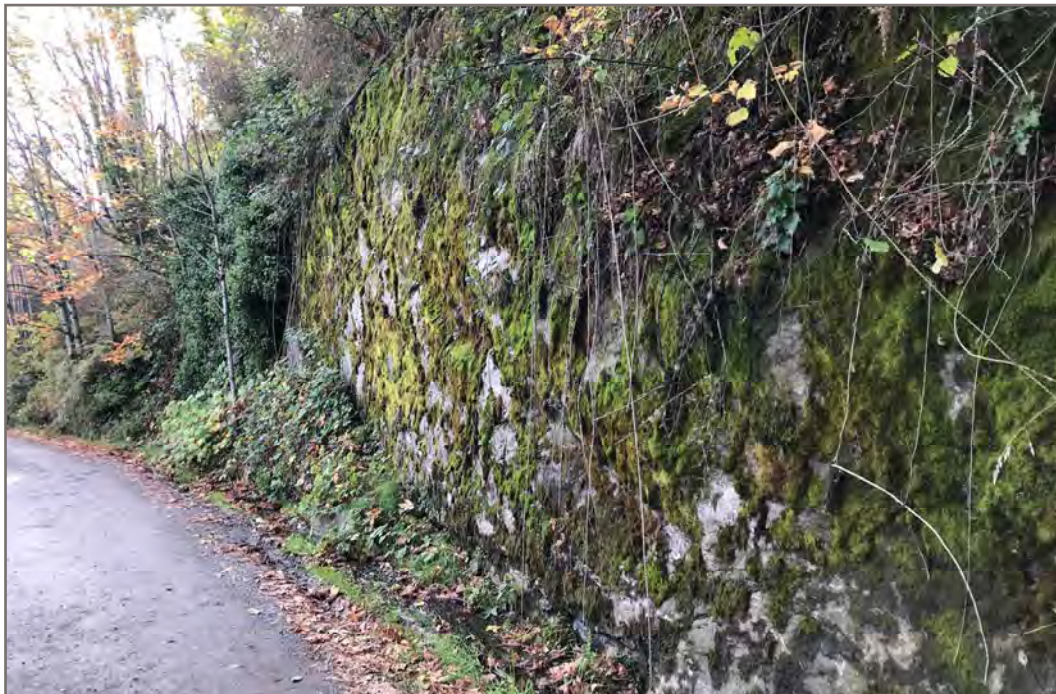
Photo 6: Bedrock Upslope of Oyster Bay Drive

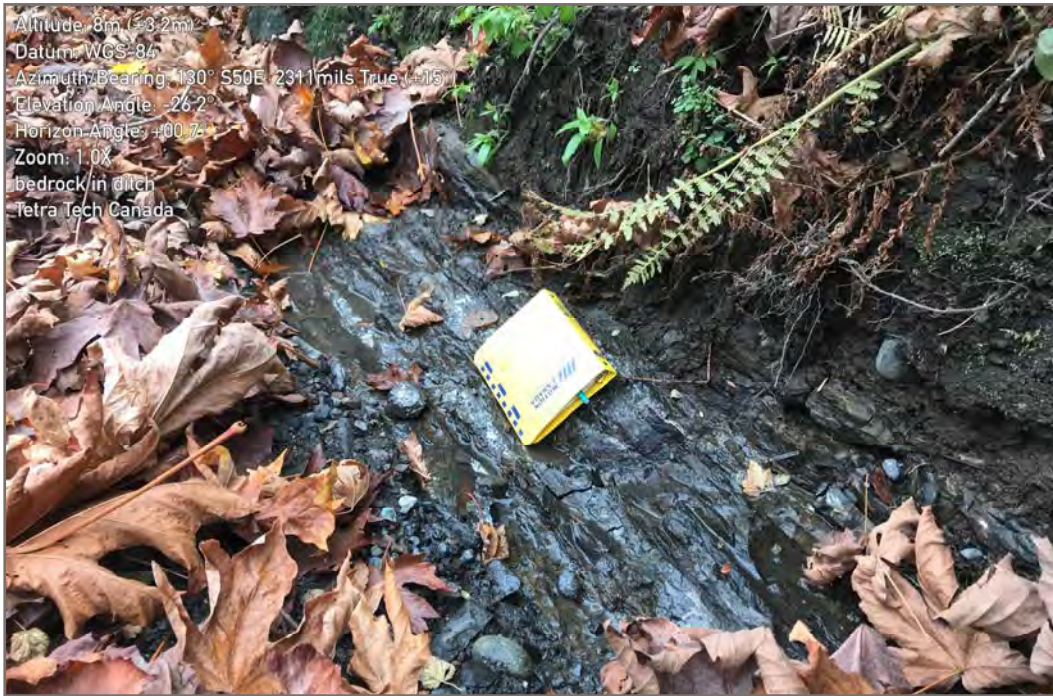
Photo 7: Bedrock Exposed in Upslope Ditch of Oyster Bay Drive

Photograph 7 – Bedrock Exposed in Upslope Ditch of Oyster Bay Drive

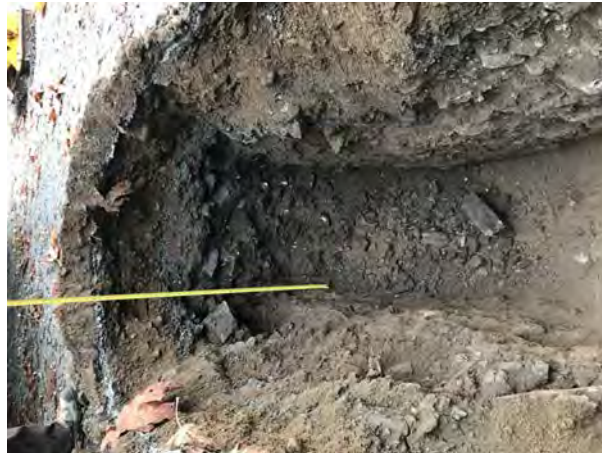
0.5		50 mm thick crush coarse gravel layer GRAVEL (MIXED FILL), sandy, cobbly, some boulders, trace silt (as isolated clumps), well-graded, damp, brown, trace rootlets and wood debris, some metal cable debris; fine to coarse angular gravel, fine to coarse sand, angular cobbles and boulders up to 1						4.0

3.5		0.3 m thick, wet orange-brown, sandy silt lens with organic odour and significant wood debris; seepage observed in testpit wall						1.0
3.5		Testpit terminated at 3.5 m (refusal on inferred bedrock). - Upon completion, the testpit was backfilled with excavated soil and bucket-packed. - Testpit location and elevation estimated based on field measurements with a hand-held GPS and are approximate (+/- 5 m). - Soil descriptions were interpreted from visual classification of recovered samples. These estimates are based on engineering judgement.					0

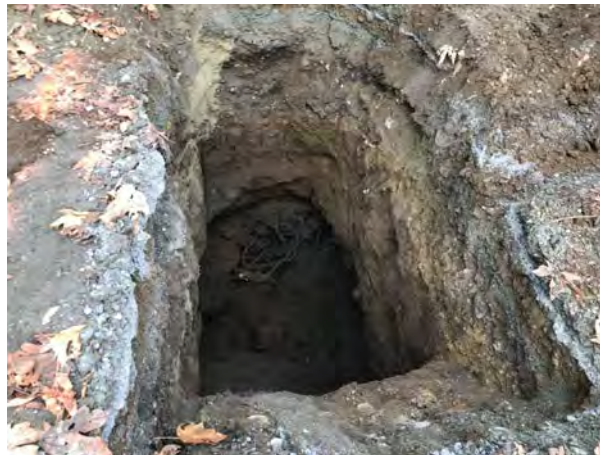
Depth (m)	Method Core Diameter (mm)	Soil Description	Graphical Representation	Field Vane (kPa)			Elevation (m)	
				Post-Peak	Peak			
0				10	20	30	40	
				20	40	60	80	
0 to 3.7	Backhoe	<p>GRAVEL PARKING LOT (100 mm)</p> <p>SAND and GRAVEL (FILL), silty to some silt, some to trace cobbles, well-graded, damp, brown, slight organic odour, trace roots; fine to coarse sand, fine to coarse sub-rounded gravel, rounded cobbles up to 120 mm</p> <p>50 mm thick crush coarse gravel layer</p> <p>SAND (MIXED FILL), silty (as isolated clumps), gravelly, some cobbles and boulders, well-graded, damp, mottled brown, odourless, some metal cable debris, trace roots and rootlets; fine to coarse sand, fine to coarse sub-angular to angular gravel, angular cobbles and boulders up to 1.5 m</p>					4.5 to 0.8

3.7		<p>wet, dark brown, sandy silt lens with organics; seepage observed in test pit wall</p> <p>GRAVEL (MIXED FILL), sandy to some sand, some silt, well-graded, wet, grey-brown, briney odour and slight hydrocarbon sheen, some metal and wood debris; fine to medium sub-rounded gravel, fine to coarse sand</p>					0.8 to 0.0	
4 to 5		<p>Testpit terminated at 3.7 m (refusal on inferred bedrock).</p> <ul style="list-style-type: none"> - Upon completion, the testpit was backfilled with excavated soil and bucket-packed. - Testpit location and elevation estimated based on field measurements with a hand-held GPS and are approximate (+/- 5 m). - Soil descriptions were interpreted from visual classification of recovered samples. These estimates are based on engineering judgement. 					0.0 to -0.5

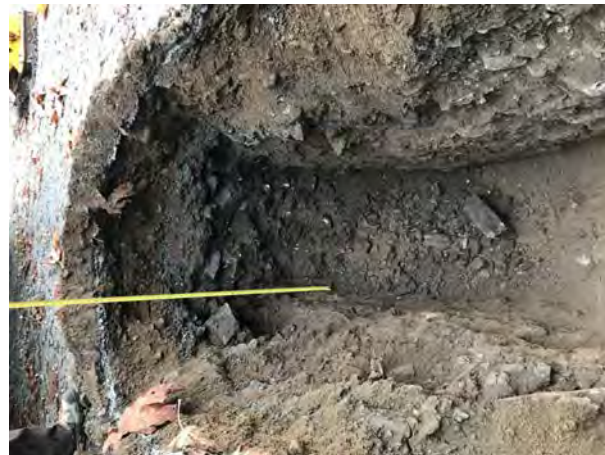
0.5		50 mm thick crush coarse gravel layer GRAVEL (MIXED FILL), sandy, cobbly, some boulders, trace silt (as isolated clumps), well-graded, damp, brown, trace rootlets and wood debris, some metal cable debris; fine to coarse angular gravel, fine to coarse sand, angular cobbles and boulders up to 1						3

3.5		0.3 m thick, wet orange-brown, sandy silt lens with organic odour and significant wood debris; seepage observed in testpit wall						1
3.5		Testpit terminated at 3.5 m (refusal on inferred bedrock). - Upon completion, the testpit was backfilled with excavated soil and bucket-packed. - Testpit location and elevation estimated based on field measurements with a hand-held GPS and are approximate (+/- 5 m). - Soil descriptions were interpreted from visual classification of recovered samples. These estimates are based on engineering judgement.					0

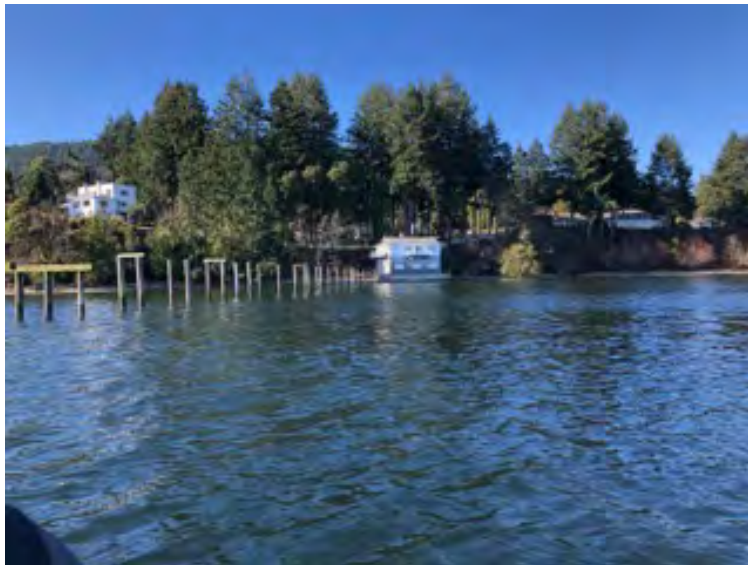
View of site depicting remains of former trestle.

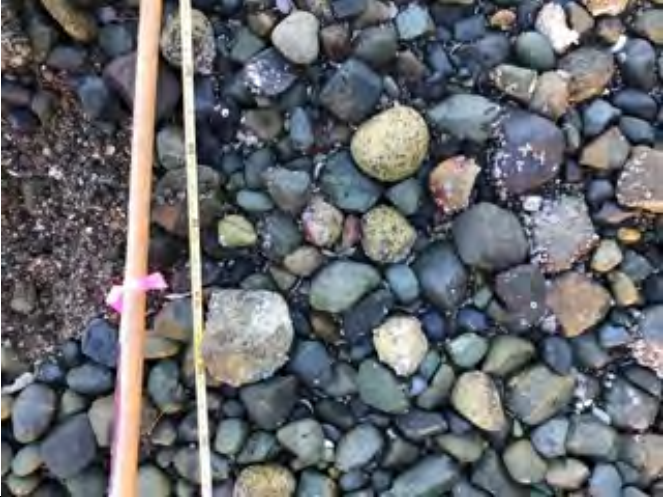
Transect	Metres from Conc. Abutment (m)	Observations	Representative Photo
IT-1 south side of trestle			
	10	Quadrat 1. Cobble over coarse sand, gravel, shell hash. Few Acorn barnacles (<i>Balanus glandula</i>) and Periwinkles (<i>Littorina</i> sp.), 2 Varnish clams (<i>Nuttallia obscurata</i>).

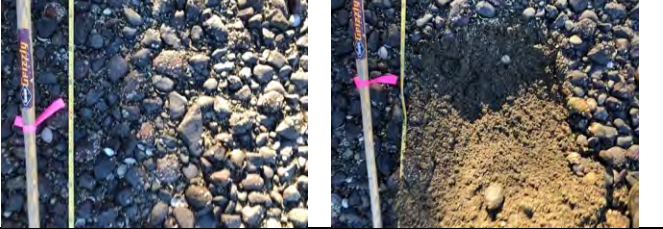
20	Quadrat 2. Cobble over coarse sand, gravel, fine shell hash. 4 Varnish clams, 1 Littleneck clam (<i>Protothaca staminea</i>).

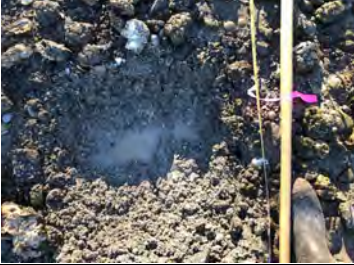
30	Quadrat 3. Few cobbles on sand and shell hash, moist with seepage. 10 Pacific oysters (<i>Crassostrea gigas</i>), Acorn barnacles, few sea lettuce (<i>Ulva</i> sp.). No infauna.

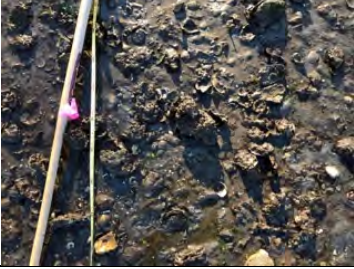
predominantly sand.	
	40	Quadrat 4. Fine sand, few cobbles, coarse shell hash & fragments. Moist. A few small red ribbon worms, 1 Butter clam (<i>Saxidomus gigantea</i>).

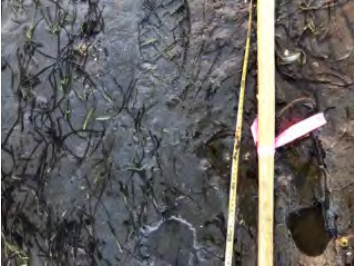
46.5	Eelgrass starts (5% cover).	
	50	Quadrat 5. Very fine moist sand, few shell fragments. Eelgrass (<i>Zostera japonica</i>) (5% cover) with relatively numerous rhizomes beneath. 5 Bent-nose clam (<i>Macoma</i> sp.), Numerous red ribbon worms, one ribbon worm (<i>Cerebratulus</i> sp.).

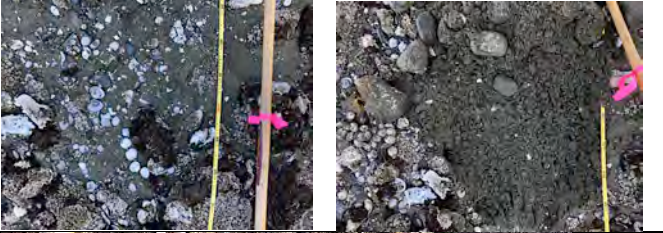
28.7	<p>Third pile bent.</p>	
	30	<p>Quadrat 3. Terrestrial detritus (leaves) over sand with boulder and cobble. Abundant Acorn barnacles and Periwinkles; 4 Pacific oysters, 31 Varnish clams, 2 Littleneck clams.</p>

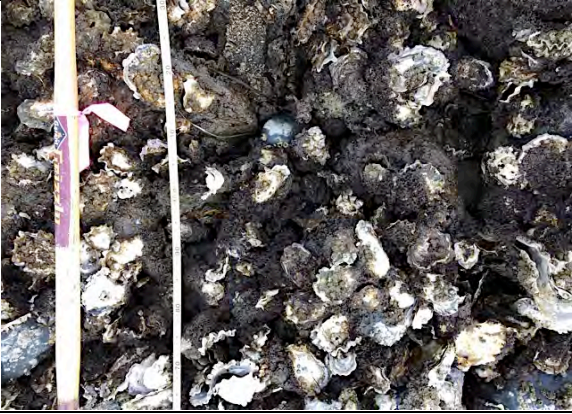
31	<p>Dense encrustations of Pacific oysters and abundant Acorn barnacles on boulders. Filamentous algae, sea moss (<i>Endocladia</i> sp.).</p>

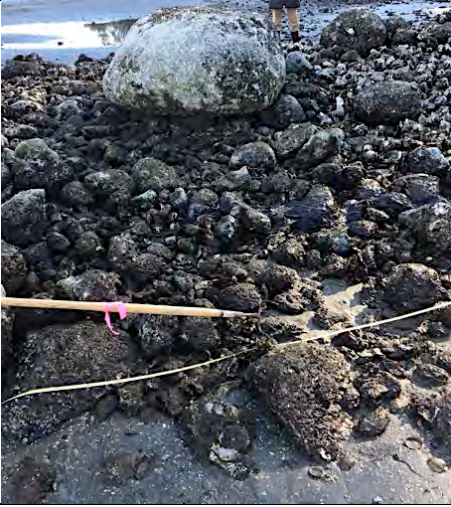
35	<p>Fourth pile bent.</p>	
	40	<p>Fifth pile bent. Quadrat 4. Boulders predominate, compact. Subsurface sediment not accessible. 30 Pacific oysters, abundant Acorn barnacles, a few Periwinkles, mussels (<i>Mytilus</i> sp.) present, 15 limpets (<i>Tectura</i> sp.), 2 shore crabs (<i>Hemigrapsus</i> sp.), filamentous algae and sea moss prevalent. Photo view to south over rock groyne.</p>

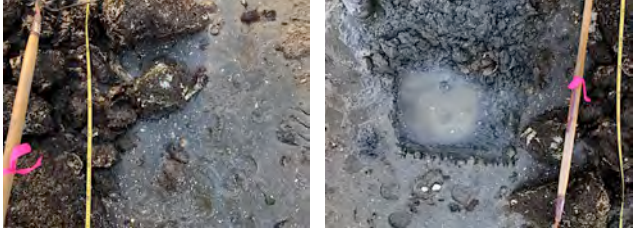
50	<p>Quadrat 5. Few boulders, cobble adjacent, fine sand and shell hash with dense rock 5 cm beneath. 5 Pacific oysters, 2 Graceful crabs (<i>Cancer gracilis</i>), 2 Bent-nose clams (<i>Macoma</i> sp.), numerous red ribbon worms, few filamentous algae, sea moss and sea lettuce, dark sea lettuce (<i>Ulvaria</i> sp.)</p>

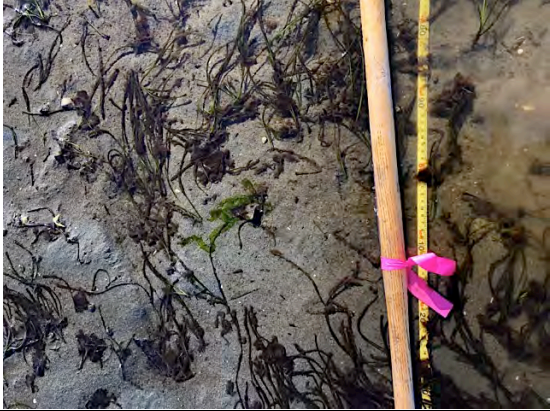
53.5	End of rock groyne.	
	58	Eighth pile bent. 10 cm water at 1552 hr March 14, 2020.	
	60	No Quadrat due to water level. See 62 m. Few decaying <i>Z. japonica</i> eelgrass fronds, few sea lettuce.	
	62	<p>Quadrat 6. Fine sand. <i>Z. japonica</i> eelgrass (10% cover), eelgrass rhizomes abundant. Some green algae.</p>

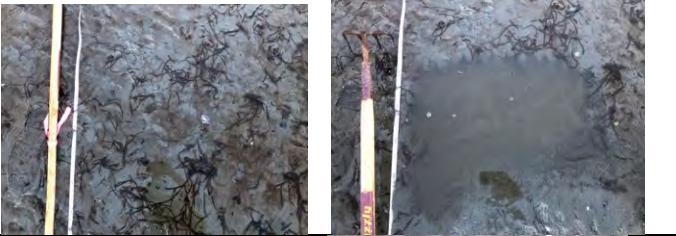
50	Quadrat 1. Fine silty sand. 1 Neridae polychaete, 1 Butter clam.

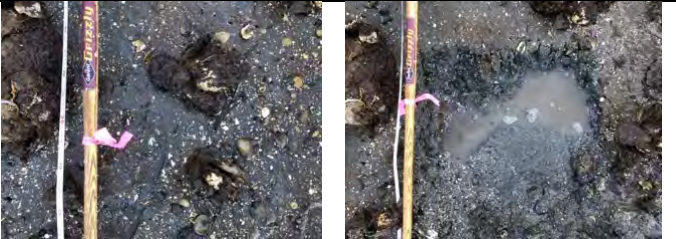
30	Quadrat 3. Few cobble on coarse sand, shell hash. 6 Neridae Polychaetes, numerous red ribbon worms.

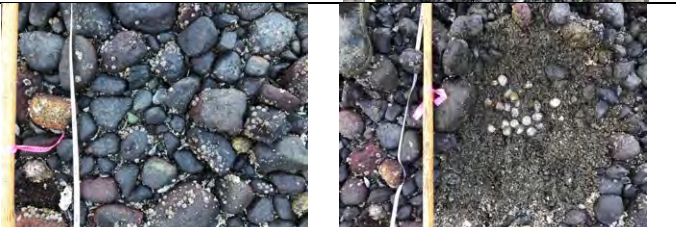
10	Quadrat 5. Cobble over coarse sand, gravel, shell hash with cobble below. Few Acorn barnacles and Periwinkles, 2 Pacific oysters, 19 Varnish clams, 3 Littleneck clams.

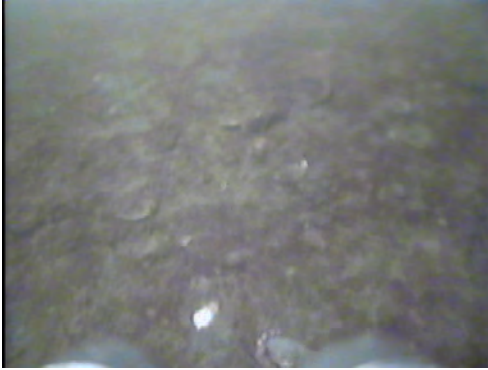
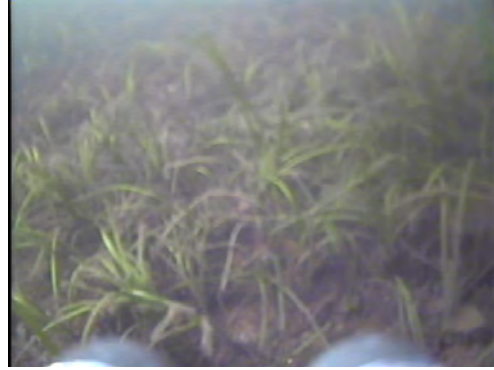
Views at 141 m and 113 m

Transect ST-1

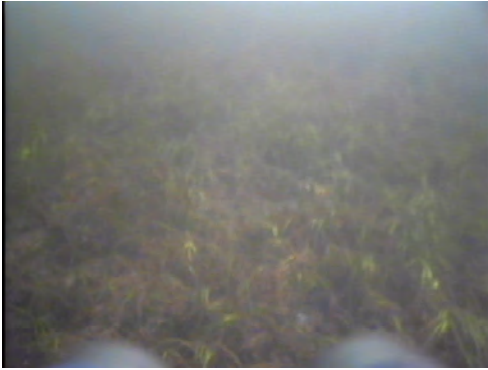
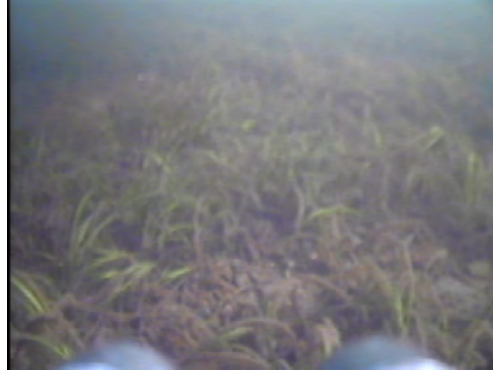
Views at 98 m and 122 m

Transect ST-2

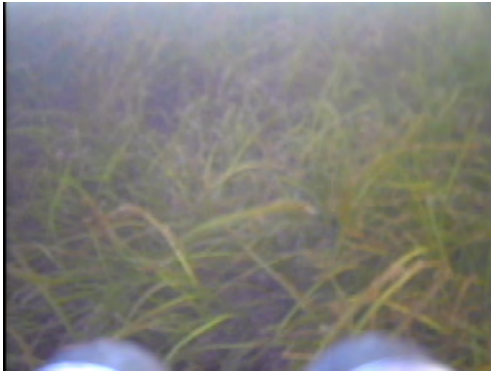
Views at 70 m and 80 m

Transect ST-3

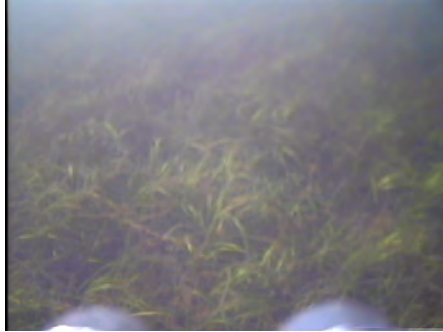
Transect perpendicular to existing trestle between bents 15 and 16.

Views at 24 m N of trestle and at 0 m on trestle alignment
